**THE CITY OF HURON, OHIO**  
**Huron Safety Committee**  
**Meeting Minutes**  
**April 15, 2020 – via Webex Teleconference 5:00p.m.**

# Nickel Plate Beach Swim Area Assessment

1 Nickel Plate Drive, Huron, Ohio 44839

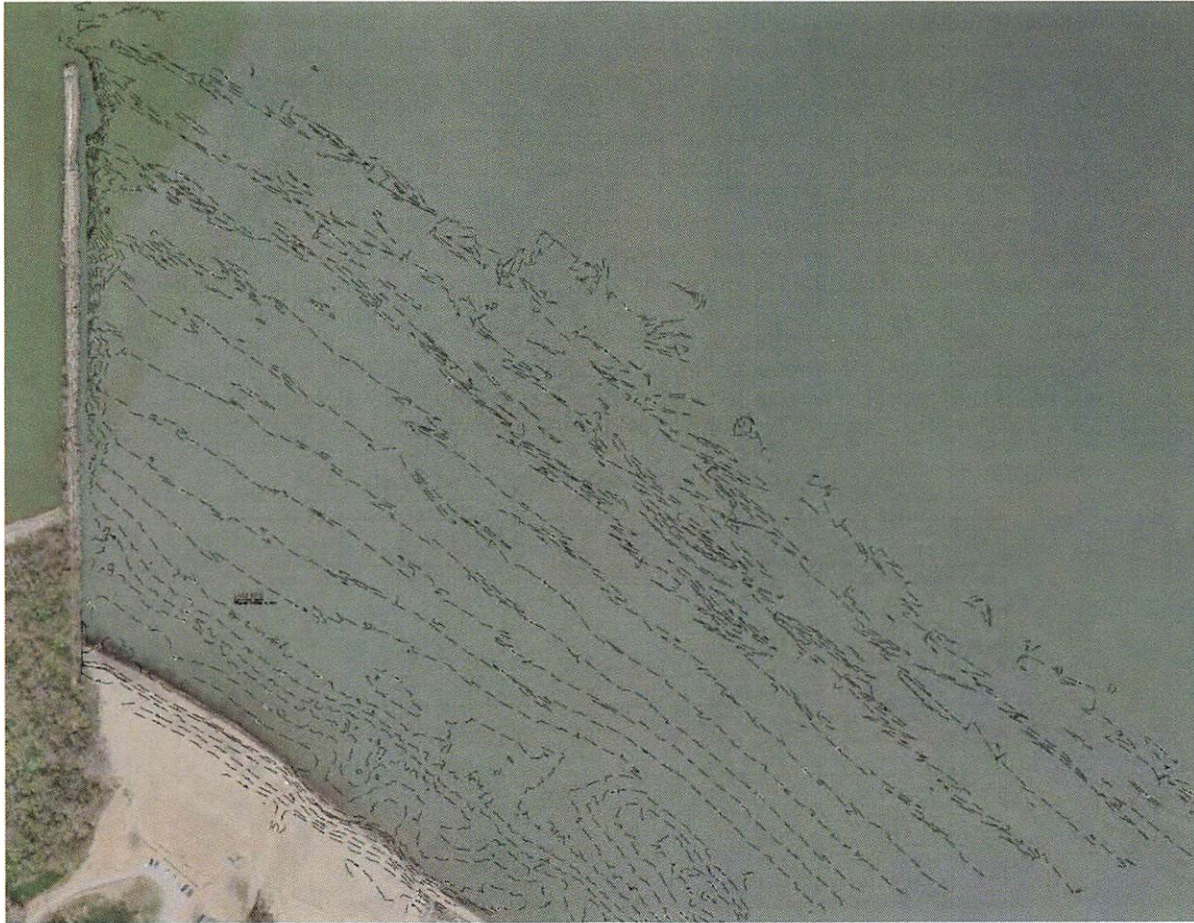
**Figure 5: Topographic and Hydrographic Survey**

KS Associates performed a topographic survey of the beach on October 15, 2019 and a hydrographic survey of the nearshore lakeward of the project site on October 23, 2019. The hydrographic survey was performed using a Seafloor HydroLite Echosounder to collect depths at intervals of 5 feet. The survey extends approximately 1,000 feet east from the Huron Harbor east breakwater and 1,300 feet lakeward from the shoreline. The topographic survey was performed for the same 1,000 feet of beach and extends approximately 100 feet landward from the shoreline. A detailed drawing showing the beach and nearshore contours generated from the survey data is included in [Attachment D](#).

The current condition of the beach from the hydrographic survey shows approximately a 1 to 50 slope which is within the 2 to 5% range suggested by the U.S. Army Corps of Engineers.

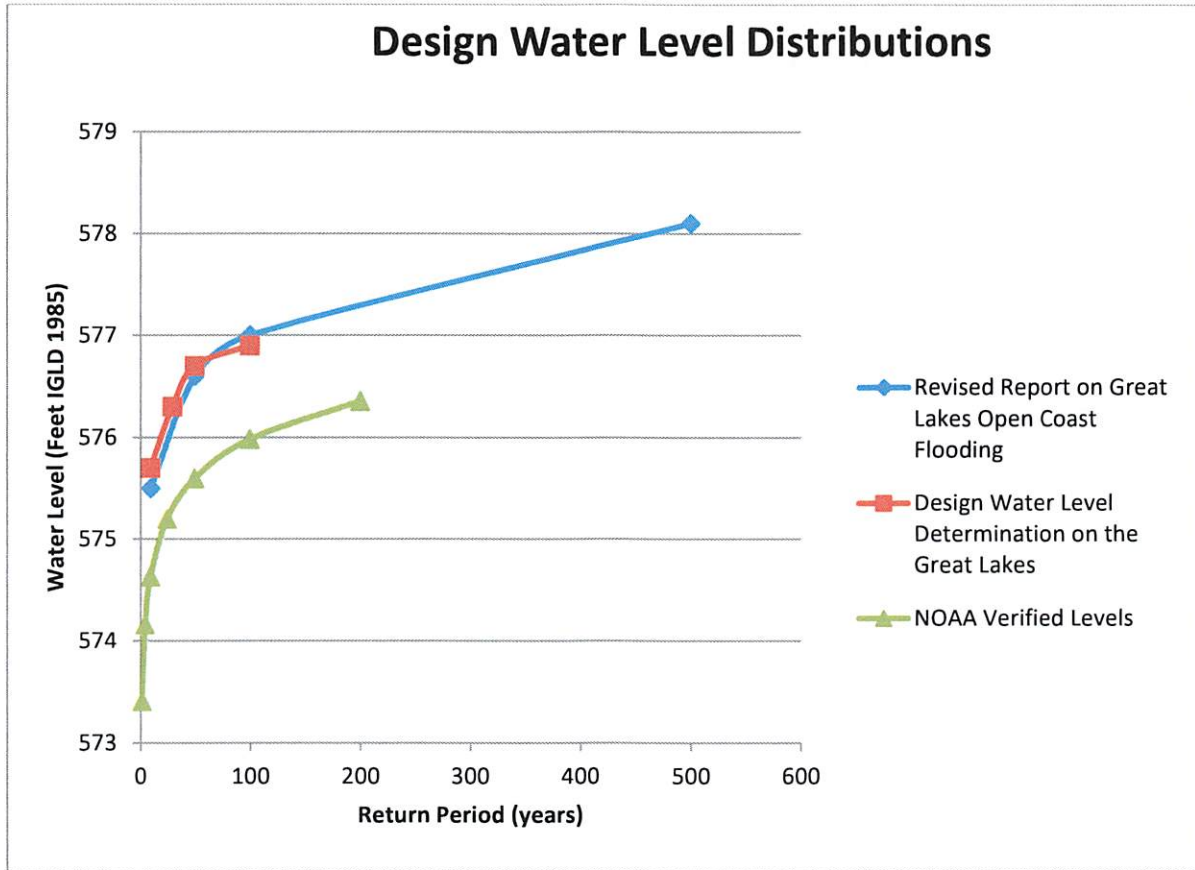
Based on the review of the historic water level information and statistical analysis described above, a design high water level of 576.0 feet (IGLD 1985) has been selected for Nickel Plate Beach. This water level is considered a reasonable estimate for 25-50-year return period conditions. The design water levels based on varying return periods are summarized in the figure below

Figure 8: Water Level Frequency Distribution

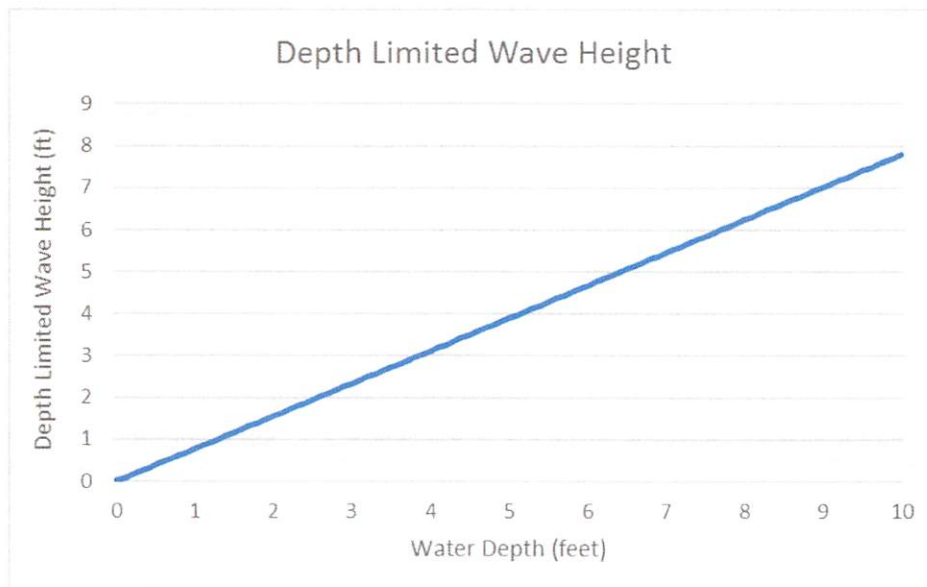
Nearshore waves will generally break when the wave height reaches about 78% of the water depth. Therefore, the largest waves that can reach the shore of Nickel Plate Beach are limited by the water depth in the nearshore or a sand bar, if one exists. It is assumed that larger waves will break farther offshore, dissipating wave energy and reducing wave heights. Nearshore wave heights at various water depths are shown in the figure below:

Figure 9: Depth limited wave heights based on wave breaking criteria.

The depth-limited case is lower than the fetch-limited or waves from the historical record (WIS data). Therefore, the largest waves developed by the selected wind conditions over the available fetch distance will break in the nearshore lakeward of the beach and wave conditions at Nickel Plate Beach are depth limited. These depth limited waves occur an average of about 30 days per year based on the WIS data.

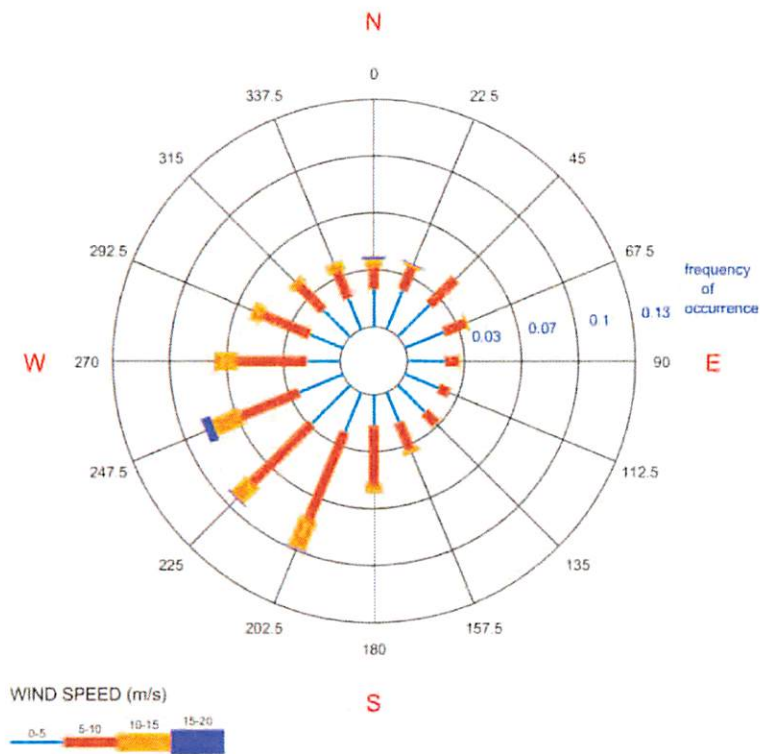
The shore of Nickel Plate Beach is exposed to open-lake wave action with a maximum fetch of about 215 miles at an angle of about 60 degrees east of north. Based on historical wind data obtained from WIS Station 92088, winds from this direction, varying 10 degrees in either direction, are expected to occur approximately 4% of the time with wind speeds ranging from about 22 to 34 miles per hour.

**Figure 10: Wind Rose—WIS Station 92088 (USACE)**

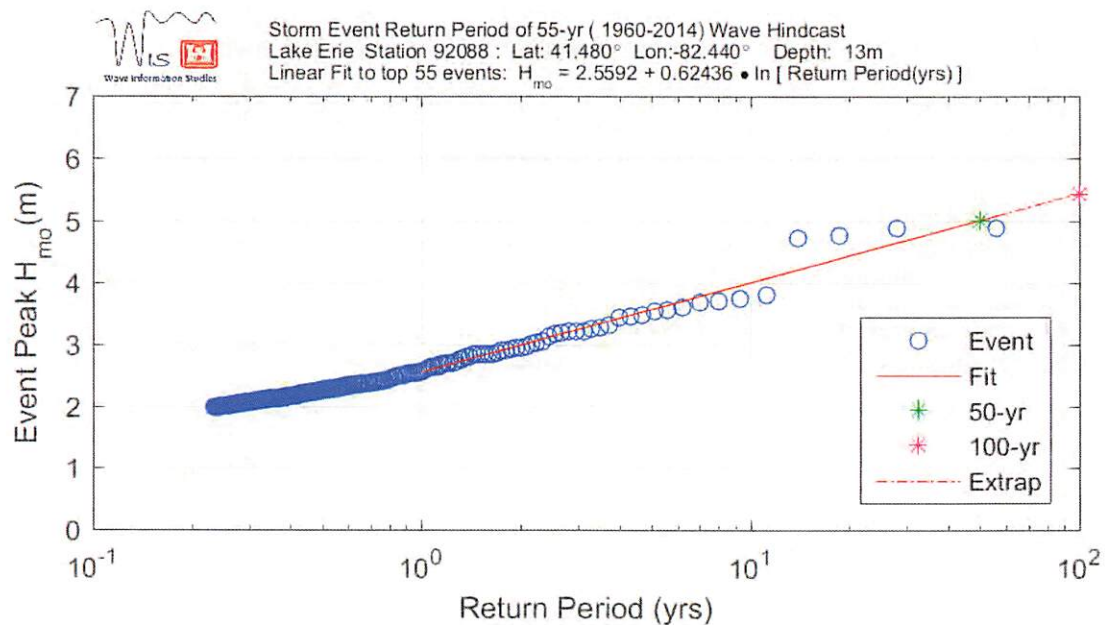
A linear regression of extreme wave events is also provided in the figure below.

Figure 12: WIS Buoy 92088 Wave Hindcast Data (USACE 1960-2014)

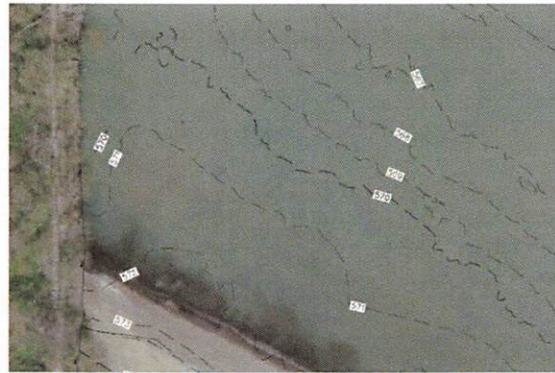
Rip currents can be generated or increased by artificial structures that disrupt natural nearshore processes. The Huron Harbor breakwaters and drainage ditch likely contribute to the rip currents at Nickel Plate Beach. The net direction of littoral current along the shore of Huron is from east to west. The Huron Harbor breakwater disrupts the flow of littoral currents and causes water and wave energy to accumulate updrift of the structure (at the west end of Nickel Plate Beach). This is also the cause of the long-term accretion of sand at Nickel Plate Beach. Water and wave energy built up in the corner of the beach adjacent to the breakwater will only have one outlet: along the structure. It is expected that strong rip currents frequently form in this area.

**Figure 13: Rip currents likely form along the harbor breakwater at Nickel Plate Beach.**

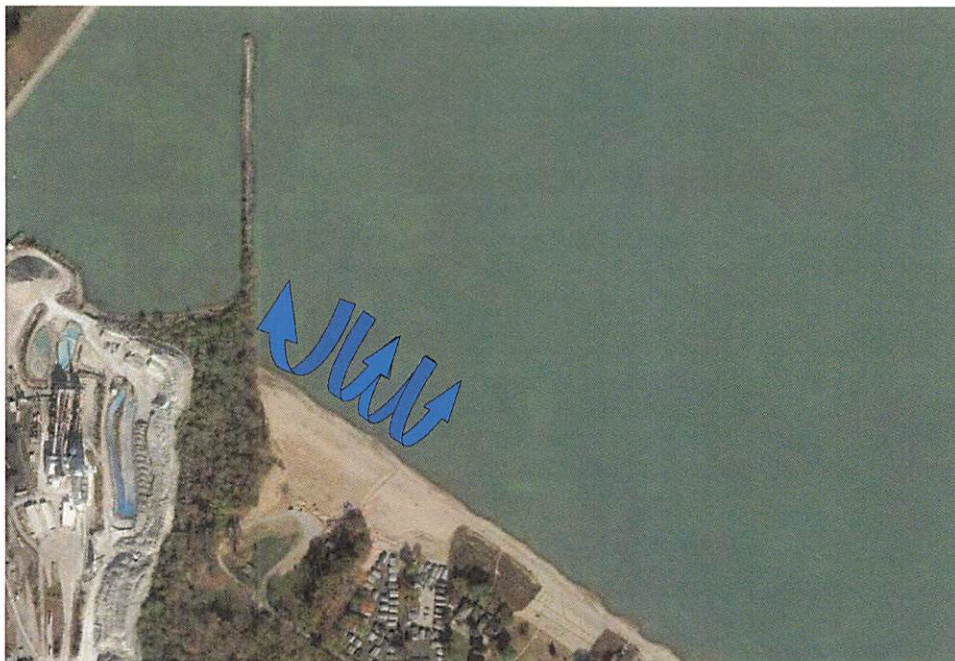
The figure below shows the approximate location of rip currents from a survey performed in 2019. The exact location of currents will change based on the wave height and direction, the movement of sand in the nearshore and the formation or movement of sand bars offshore.

**Figure 15: Approximate locations of rip currents at the time of the hydrographic survey in 2019.**

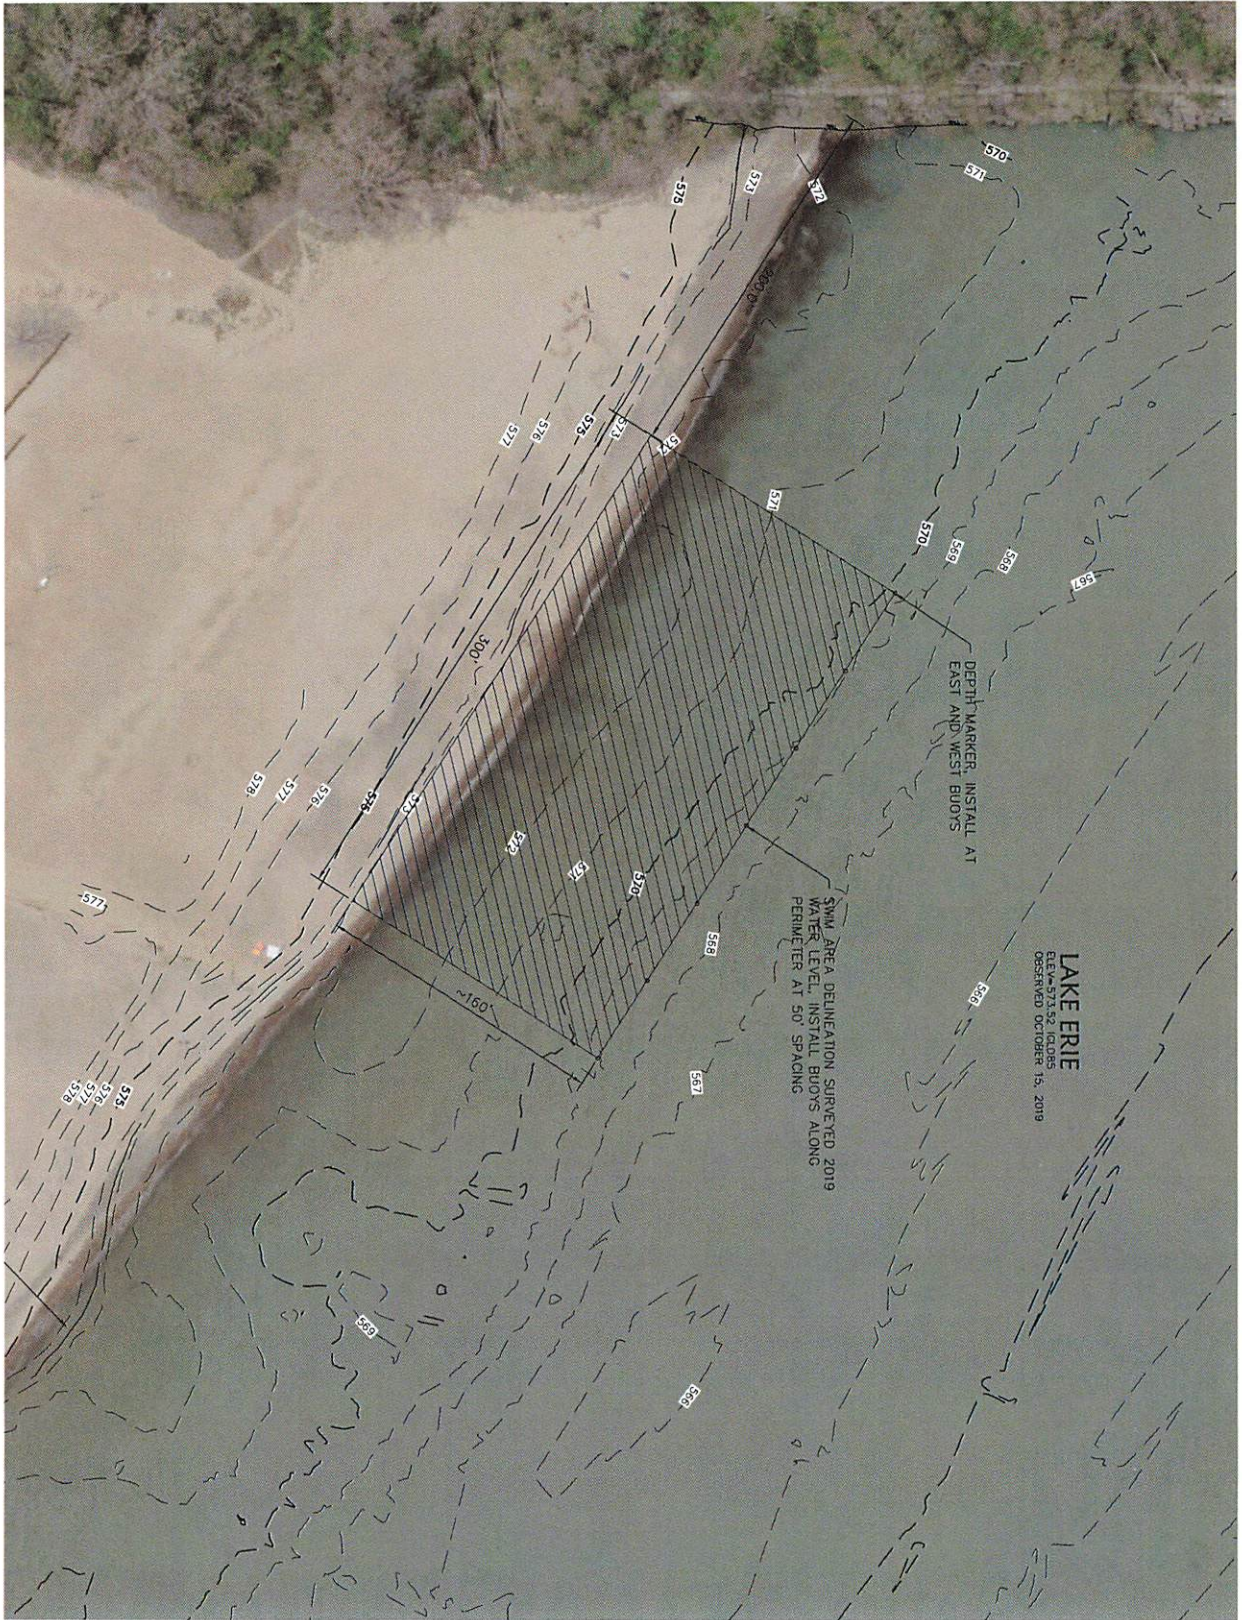
SITE PLAN  
NICKEL PLATE BEACH  
SWIM CONDITION EVALUATION  
CITY OF HURON  
1 NICKEL PLATE DRIVE,  
HURON, OHIO 44839

LAKE ERIE  
ELEV.=273.32 IGDS  
OBSERVED OCTOBER 15, 2019
